UNDERWATER BRIDGE INSPECTION REPORT

STRUCTURE NO. 23501

ROOT RIVER

DISTRICT 6 - FILLMORE COUNTY

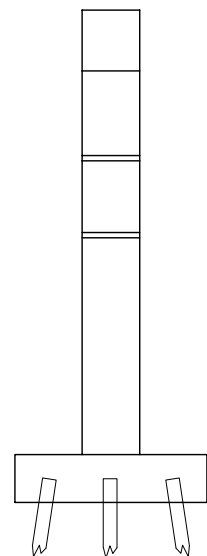
TYPICAL END VIEW OF PIERS

- 3 The channel bottom consisted of soft silt with up to 1.5 feet of probe rod penetration.
- 4 A vertical hairline crack was observed at the midpoint of Pier 2 that extended from the top of the pier cap to 2 feet below the waterline.

- 5 A vertical hairline crack was observed at the midpoint of Pier 2 that extended from the top of the pier cap to the top of the footing.
- 6 Light scaling was observed along all pier faces from 1 foot above to 1 foot below the waterline with a maximum penetration of 1/16 inch.

- 7 A heavy accumulation of 2-foot-diameter-and-smaller timber debris was observed extending from the channel bottom to 2 feet above the waterline at the upstream end and along both faces of Pier 1.

- 8 A 1.5-foot-diameter tree trunk and smaller timber debris was observed extending from the channel bottom to the top of the pier cap at the upstream end of Pier 2.

- 9 The footing was exposed at Pier 2 with undermining and steel H-piles observed from the midpoint along the east face, around the upstream southeast corner, and extending to the midpoint of the upstream end with a maximum height of 1 foot all along the undermined area, and 4 to 5 feet of horizontal penetration. The exposed steel H-piles were sound without any notable deterioration.

- (A) Remove the heavy accumulations of timber debris around Piers 1 and 2 to alleviate adverse effects for the channel bottom and the piers.
- (B) Scour rating indicates that bridge has the potential to be at greater risk for scour with further scour analysis required. Giving the undermining, consideration may need to be given for riprap to be properly designed and placed around the piers and in the scour/undermining areas to armor against further scour, unless further scour analysis indicates differently.
- (C) Reinspect the submerged substructure units at the normal maximum recommended (NBIS) interval of five (5) years.
